MiG-23

Airworthiness Certification

AIR-230 Airworthiness Certification Branch
Federal Aviation Administration
Washington, D.C.
January 21, 2013

Introduction – MiG-23 Airworthiness Certification

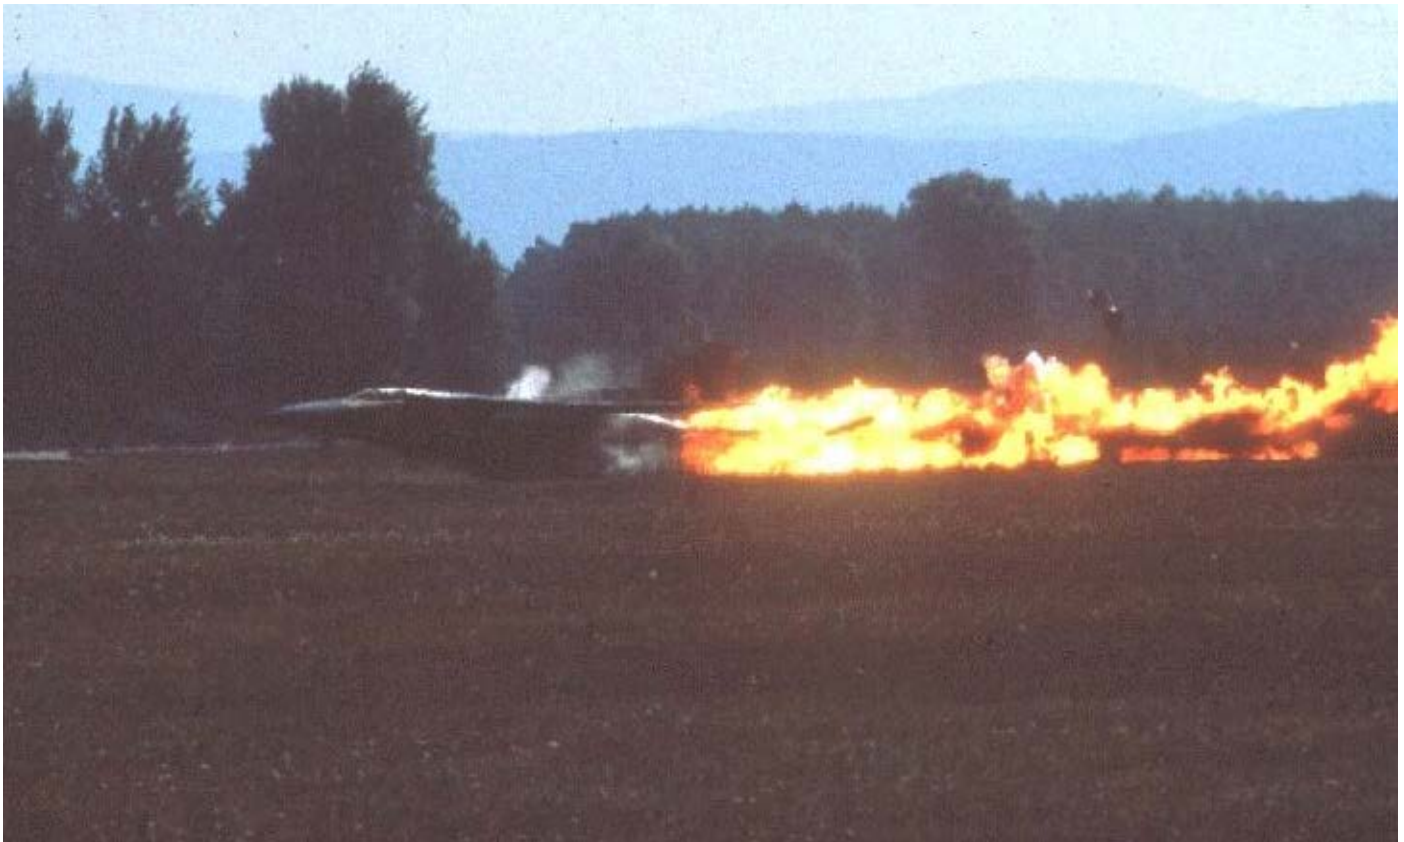
Fatal accident of a Hungarian Air Force MiG-23MF during an air display at Papa AB on September 16, 1990. The accident was the result of the pilot operating the aircraft with the wrong wing swept setting at low altitude while maneuvering. Source: Georg Mader. Copyright © 1990. www.airliners.net.

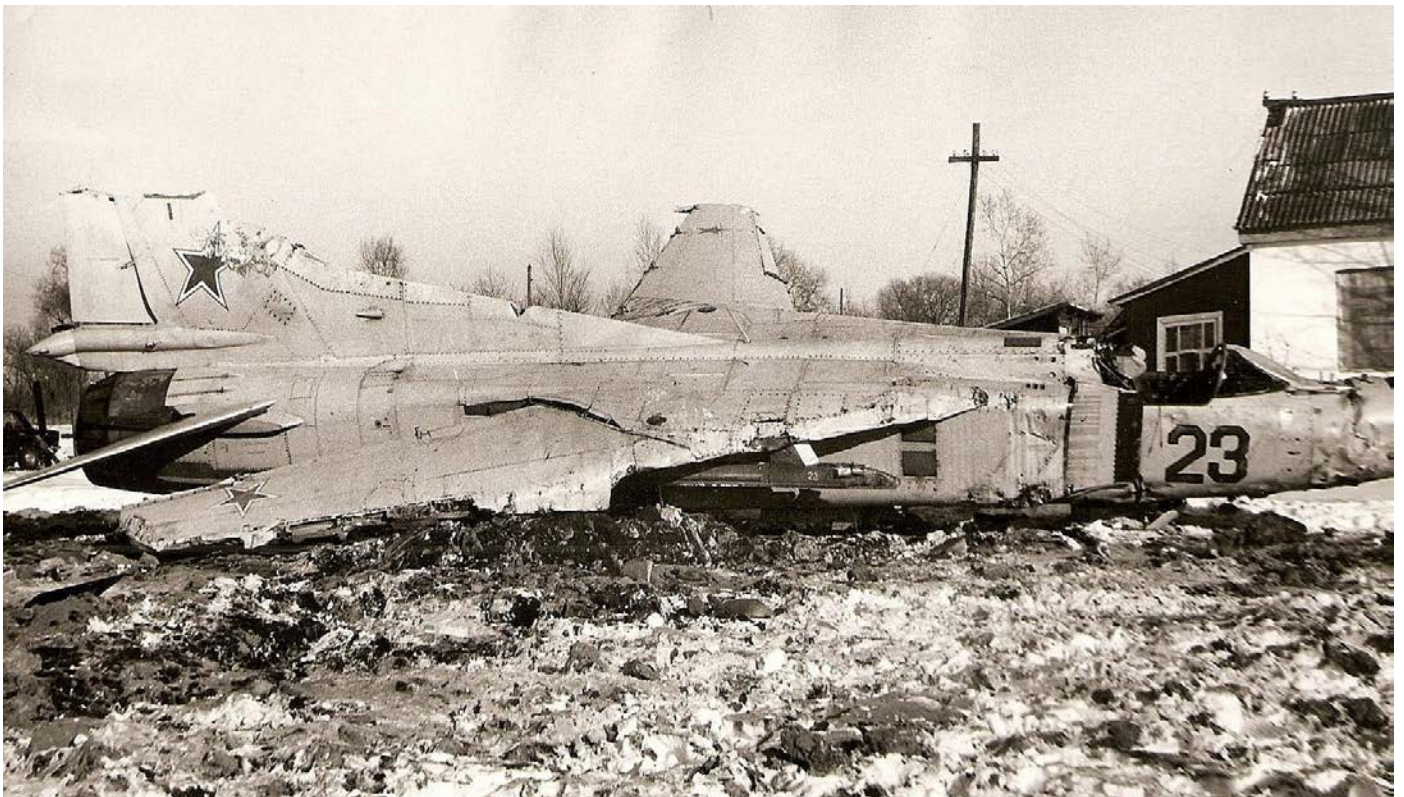
Soviet MiG-23 accident in the 1980s at Vladivostok. Source: Georg Mader. Copyright © 2013.
